Property Damage Claims

Case Profiles- Cost Reduction and Early Reporting Benefits

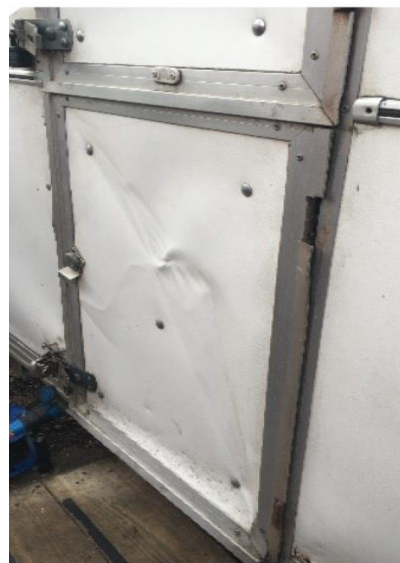
It was reported that the Policyholder vehicle impacted the corner of the food van, whilst reversing, resulting in consequential damage.

Our intervention team instructed a surveyor to attend and inspect the van. They identified that the damage was isolated to the rear corner and the impact had caused the side panel to bow. This resulted in further damage to the door of the van, which was open at the time of impact.

The third party presented a claim for £5,500.00 for a replacement van in a similar condition. Based upon our surveyor's findings and through subsequent investigations the claims handler identified the catering van was over 16 years old, with the condition of the van showing signs of wear and tear, as well as evidence of previous repairs from past impacts.

Based on discussions with specialist repairers, it was determined that the cost of repair deemed the unit to be beyond economical repair. Due to the condition of the van at the time of the incident the claims handler explained to the third party that we would be unable to agree full costs for a replacement van, as we had to consider the existing condition and age.

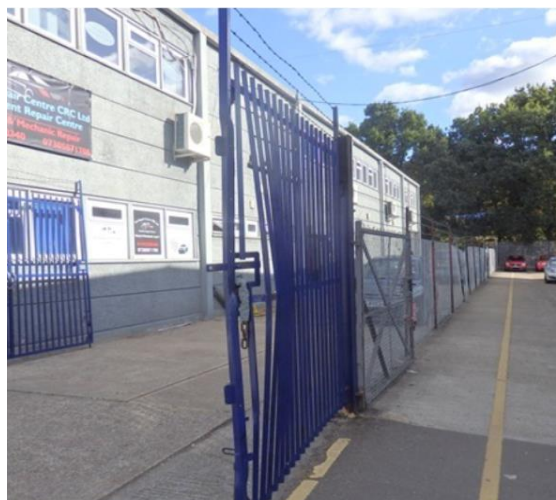
Vehicle damage to a third party's commercial gate.

At the point of our instruction's repairs had not yet been completed, immediately we arranged for one of our surveyors to attend site. Upon inspection the surveyor confirmed the gate frame had been bent and that the vertical metal railings were out of alignment, the damage was consistent with an impact and was to the right-hand gate only.

The gate no longer fitted flush with the left-hand gate and for security reasons the third party had fitted a chain and padlock.

The third party presented a claim for £4,128.00 which allowed for the replacement of both gates, however our onsite inspection confirmed there was no damage to the left-hand gate.

Based upon our surveyor's findings the claims handler explained to the third party that our client's liability would be for the damages sustained to the right-hand gate only.

Our ability to inspect the property damage prior to any repairs being undertaken ensured we identified the extent of the damages. Settlement was agreed in line with our surveyor's valuation for repairs to the right-hand gate at £2,000.00, resulting in a saving of £2,128.00 / 52%.

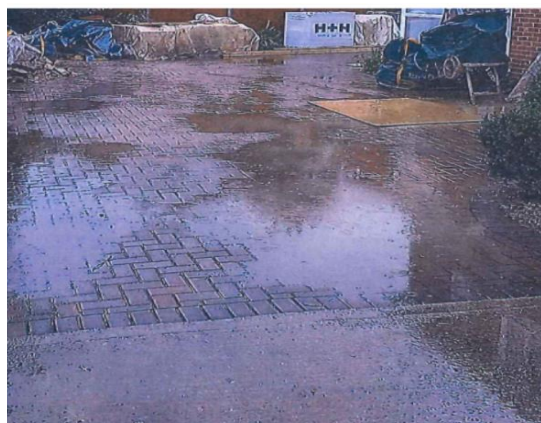
Vehicle damage to a private property driveway.

The weight of the vehicle had allegedly damaged the foundations of the driveway, the whole driveway needed replacing. As a result we had a claim presented for £19,500. They referred the incident to Artemis and this is how we worked as an extension to our client to investigate, manage and finalize the claim.

Our intervention team instructed a surveyor to attend the risk address. The surveyor confirmed that full repairs had already been completed and the third party received a cash settlement. Whilst the surveyor was on site, the third party revealed some key information in this claim. The claimant confirmed other works were being undertaken at the time of incident and there was existing damage to the driveway. The principal contractor confirmed that our client's policyholder could use the driveway. This turned out to be crucial in the next steps.

In addition to the surveyor attending site, our civil engineer reviewed damage images. This led to relevant comments on the previous condition of the driveway and concerns of the existing foundations.

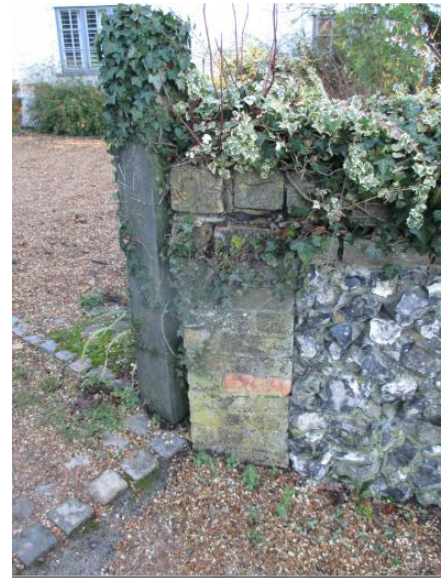
Damage to a third party's 300 year old external wall.

The age and condition of the wall dictated that this was not an ordinary repair, and specialist contractors would need to be employed to preserve as much of the fabric of the existing wall as possible.

The claimant did not have access to specialist repairers capable of handling the type of rectification work needed, and we were able to appoint contractors capable of managing this repair end to end and maintaining the historic nature of the damaged wall

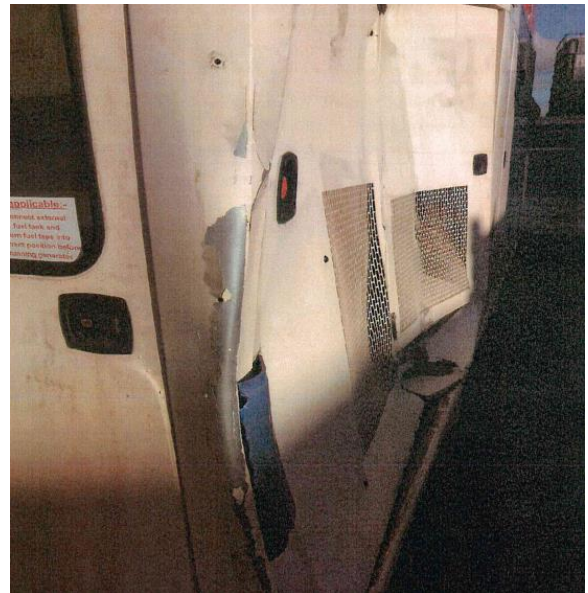
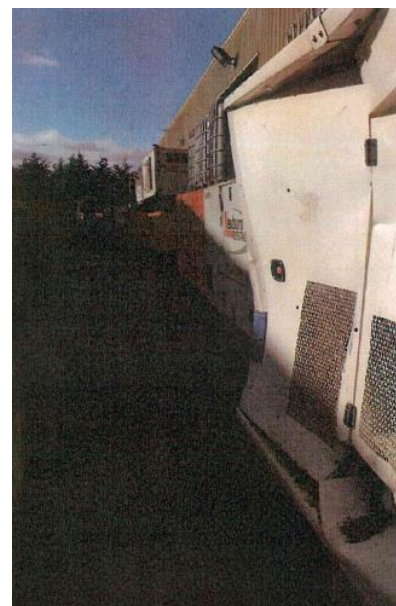
Crushing damage sustained to a 500kva generator.

Damage has been sustained as a result of concrete panelling falling from the policyholders vehicle. A claim for circa £110,000 was subsequently submitted.

The damage sustained was genuine and as a direct result of the negligence of the policyholder. However a significant proportion of the claim related to the damage of the concrete panels themselves, which were in fact covered under the goods in transit insurance policy that the policyholder had.

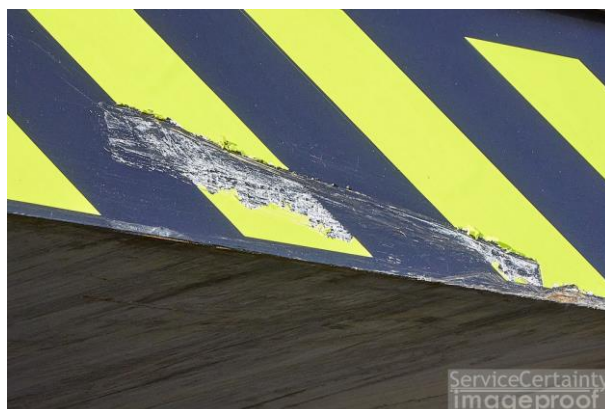
It was reported that an over height trailer has struck the railway bridge resulting in the destruction of the trailer and closure of the road for 6 hours

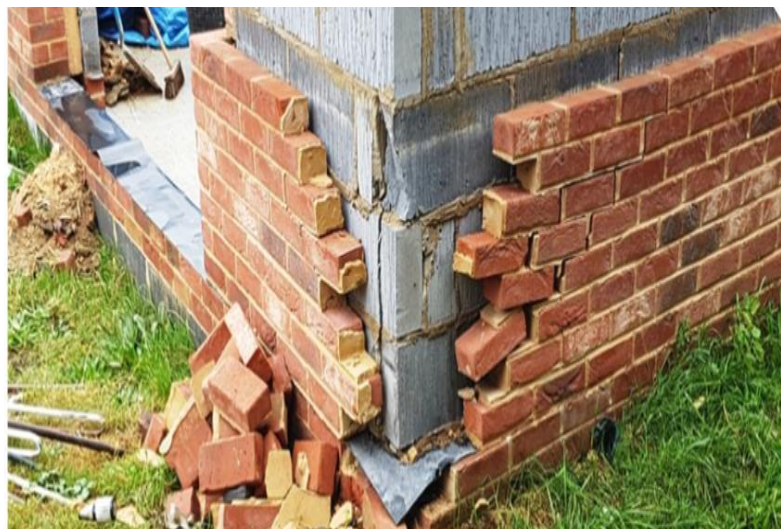
Vehicle damage to a third party's corner section of brick and block work.

It was reported that the Policyholder vehicle collided with a section of the corner brick and block work, whilst collecting a shipping container.

Upon inspection the Surveyor confirmed that the third party was in the process of constructing a bungalow, when the Policyholder vehicle collided with the corner. Damage had been sustained to a section of the outer skin brickwork and inner skin thermalite blocks. The Surveyor also confirmed that there was no indication that the foundation had been affected.

Through subsequent discussions with the third party and based upon our Surveyor's findings the claims handler negotiated a settlement at £2,000.00 for the damage area only.

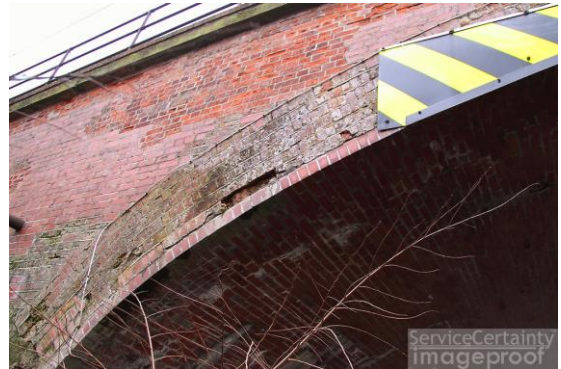
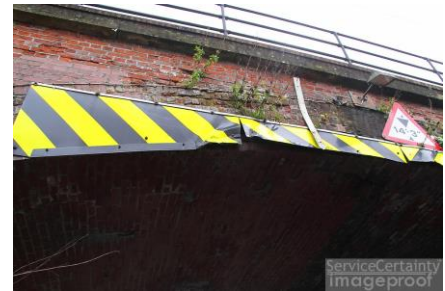
It was reported that significant damage has been sustained to the policyholder's trailer. The driver was adamant that the height markings on the signage leading up to the bridge and on the bridge itself were incorrect.

The impact took place on the 14th December 2018 and was reported immediately by the broker. The driver alleged the height restriction signage was incorrect, and the bridge was effectively undamaged.

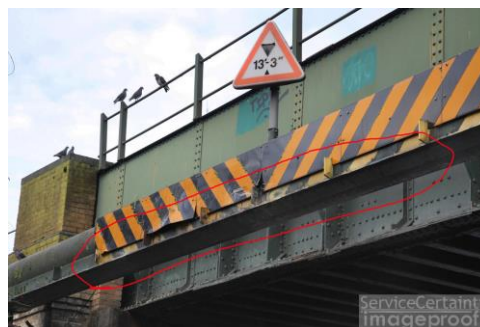
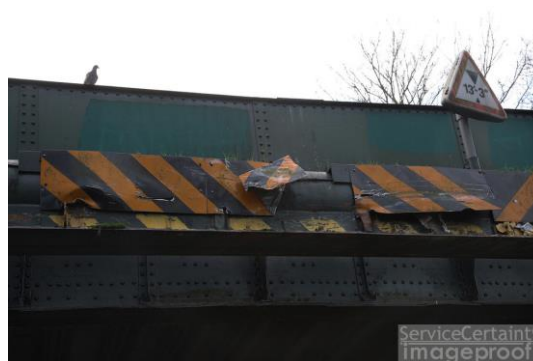
It was reported that there had been a modest collision between the roof of the trailer and the bridge.

Details of the damage were unclear. We made arrangements for high resolution images to be obtained of the bridge so that we could fully understand the extent of any claim that may be presented.

These images were available within 3 working days of the claim report and clearly demonstrated that this bridge has pre existing damage associated with numerous impacts.

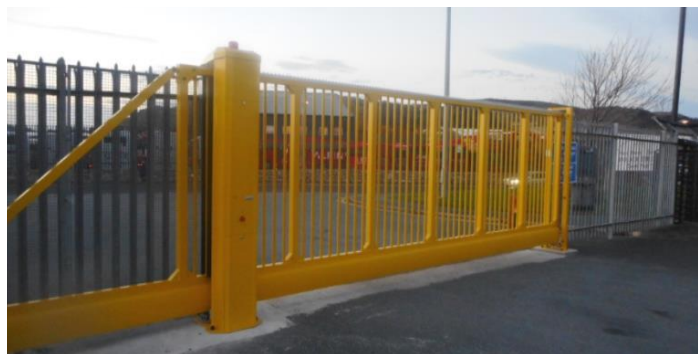
Vehicle damage to a third party's commercial entrance gate.

It was reported that whilst the Policyholder was maneuvering they impacted the automated security gate.

At the point of our instruction repairs had already been undertaken, we immediately contacted the third party to arrange for one of our Surveyors to inspect the property. Upon inspection the Surveyor identified that the replacement gate did not match the gate in situ at the time of the incident. The new gate was significantly larger and had been fully painted. The Surveyor recorded all the dimensions of the gate, alongside a video capture and written report.

The third party submitted an invoice totalling £18,465.72 for the repairs, however from our Surveyor's findings it was evident the gate had been upgraded. This was discussed with the third party, alongside our Surveyor's valuation to replace the gate on a like for like basis. Settlement was subsequently agreed in line with this valuation at £12,000.00.

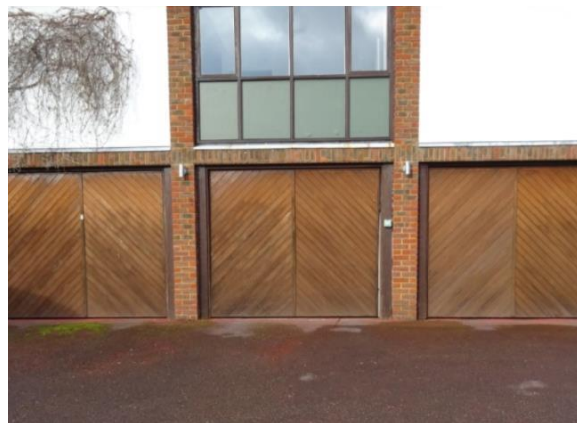
Vehicle damage to a third party's electric garage door.

Upon inspection the Surveyor confirmed damage had occurred to the central garage door, the third party had four matching doors in total. Whilst the Surveyor confirmed the impacted door was damaged beyond economical repair, they also established that only one had been damaged as a result of the incident. All four doors had the same identical design.

Based upon our Surveyors findings, that only one door had been damaged in the incident, the handler explained that our client would only be liable to replace the signal door. During subsequent discussions settlement was agreed at £2,490.00, allowing for the costs to replace the single door only.

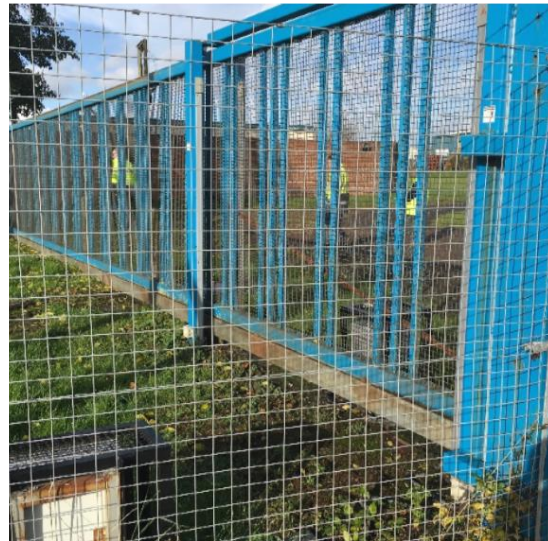
Vehicle damage to a third party's automated sliding gate.

It was reported that whilst the Policyholder was reversing, they collided with the automated sliding gate at the site entrance.

Upon inspection the Surveyor identified that the HGV had impacted the gate post, resulting in the post becoming distorted. The gate had partially detached from the drive mechanism and the electronic controls had snapped off the gate. The Surveyor confirmed that in their opinion the damages could be repaired.

The third party submitted a quotation for the replacement of the entire gate system for the sum of £12,744.00 plus VAT and at the time of our instruction they had appointed a solicitor to represent them. The claims handler discussed our Surveyor's findings with the representative and explained that we have *specialist commercial gate contractor* on our repair network that would be able to affect a repair. Once agreed with the third party and their representative, we instructed our contractor to provide a quotation and they were able to undertake all repairs for the sum of £6,450.00 plus VAT.

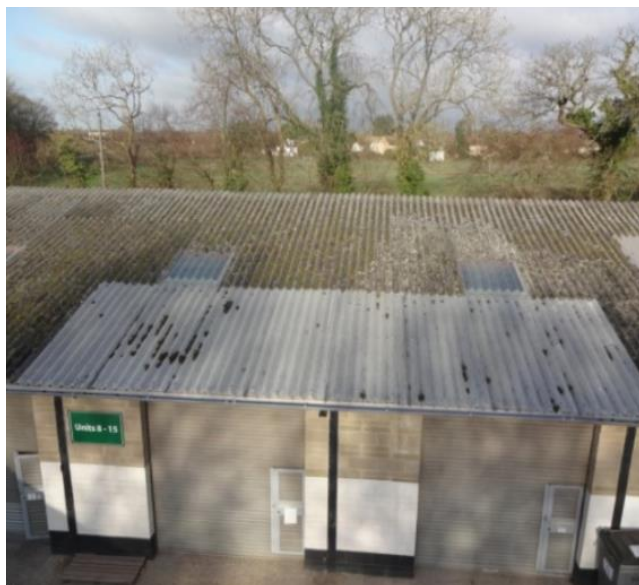
Vehicle damage to a third party's roof and canopy.

The Surveyor identified areas of repair consistent with the incident, including the inner and outer timber canopy support beams which had been replaced, alongside the corrugated sheet roof panels directly above. However, the Surveyor also identified recent works, including to the guttering and sheeting that appeared to be unrelated to the incident.

The third-party representative presented an invoice for repairs totalling £8,254.80, through subsequent discussions the claims handler outlined our Surveyors findings and it was confirmed that works had been undertaken to the guttering and sheeting due to a pre-existing maintenance issue. It was explained that our client would not be liable for these costs and settlement was agreed, in line with our Surveyors valuation, for the repairs required due to the incident only at £5,500.00.

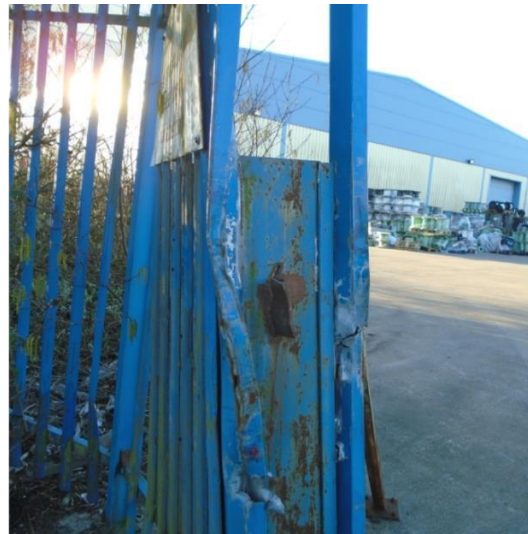
Vehicle damage to a third party's electronically operated gate and post.

The Surveyor identified that the impact to the post had caused it to lean, with the adjacent fence panel also affected. It was confirmed that both the fence post and panel would require replacement. The Surveyor also noted that the gate and post were in a poor pre-loss condition with evidence of rusting and degraded areas.

The third party submitted a quotation for repairs to the damaged areas totalling £2,300.00, however based upon our Surveyor's findings the claims handler explained that we would not be liable for the full repairs due to the pre-existing condition of the gate and post. Settlement was subsequently agreed at £500.00.

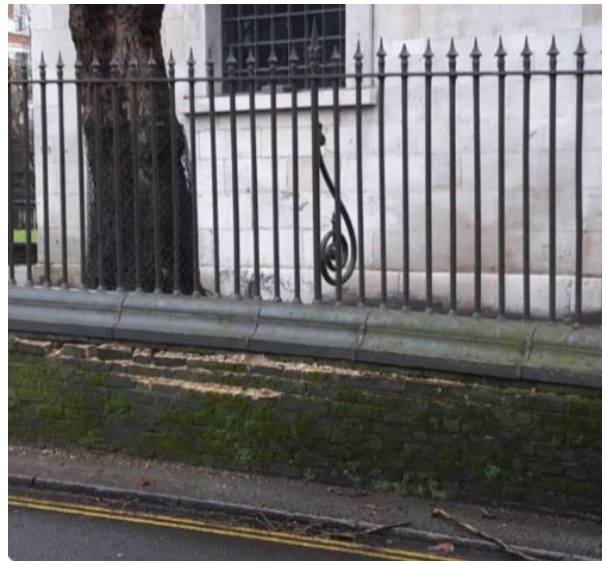
Vehicle damage to a Grade II listed set of metal railings and wall.

It was reported that the Policyholder vehicle collided with the wall and railings, whilst reversing from a delivery site opposite the third party.

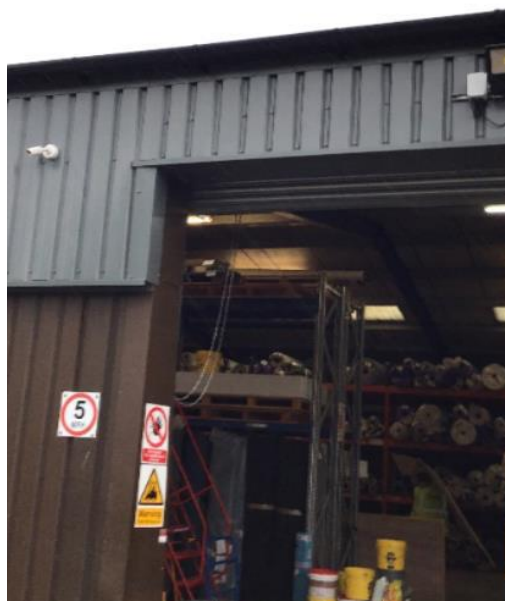
Repairs had already been undertaken. We proceeded to instruct a surveyors to inspect the property and they identified that recent repairs had been completed to a greater area than those damaged in the images taken at the time of the incident.

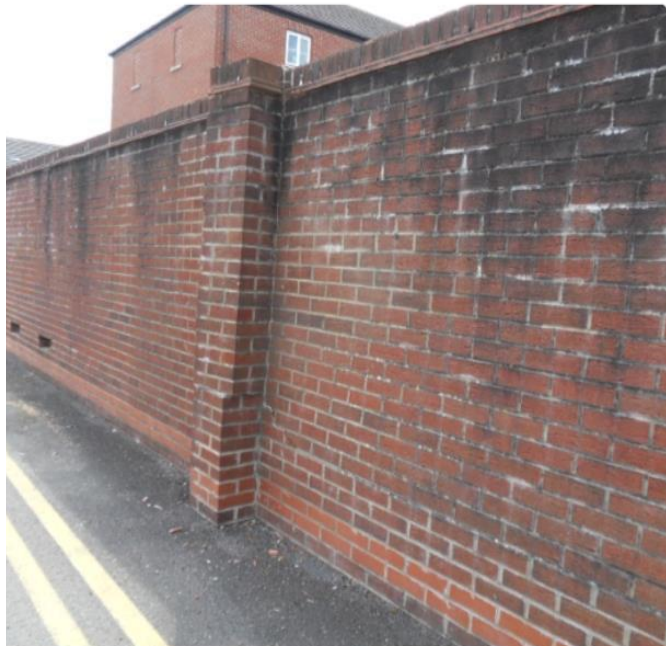
Repairs had not yet been completed, so we immediately instructed a surveyor to attend site and inspect the damages. They confirmed that the damages were consistent with the impact and that the affected area measured 2.1m. The wall was noted as substantial in size and showed no evidence of pre-existing damage.

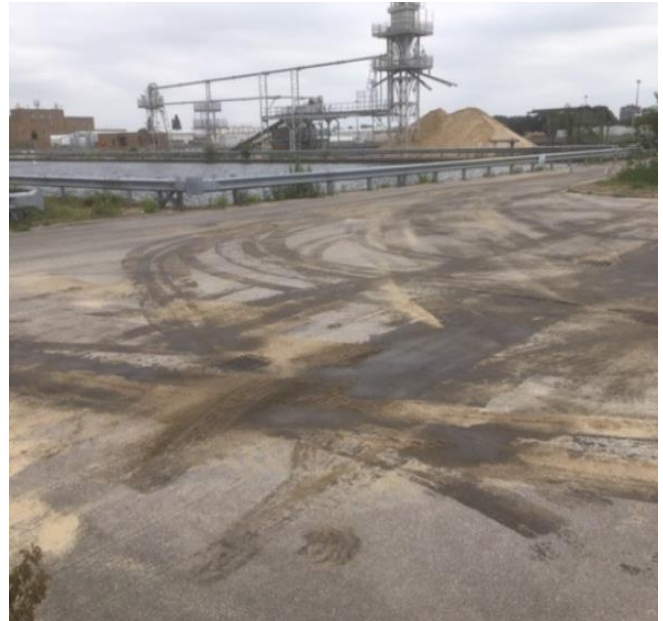
It was reported that the Policyholder's sweeper lorry was cleaning the surface, when the hydraulic pump burst, resulting in hydraulic oil spilling onto the tarmac surface and contaminating one of the filter beds.

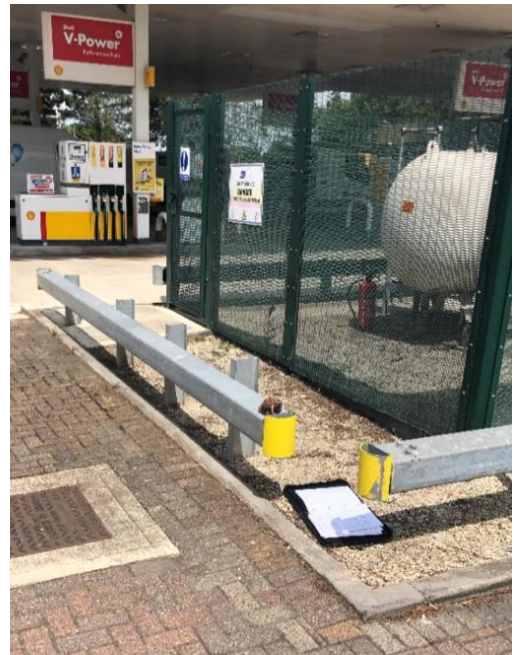
Repairs had already been undertaken. We proceeded to instruct one of our Surveyors to inspect the property and they identified that the entire entrance side and end side of barrier were replaced, along with the majority of concrete posts.

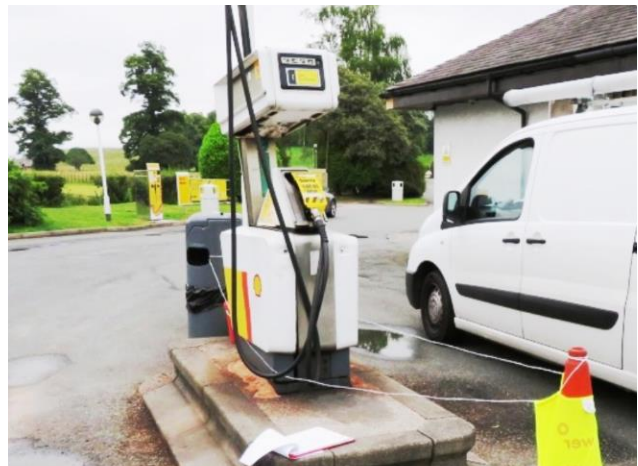
It was reported that the Policyholder collided with the top of the diesel pump, lifting the unit from its base.

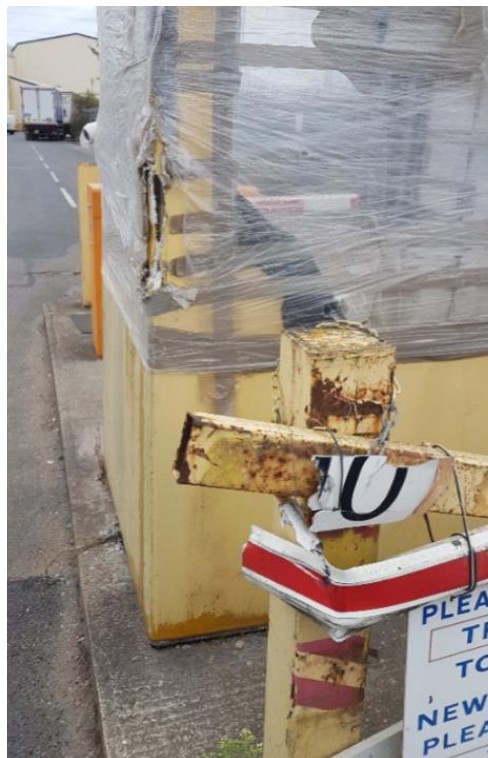
The inspection confirmed that the security cabin had been impacted at the front corner, resulting in a hole in the fibreglass structure. A further crack was noted above the entrance door to the rear of the cabin. The metal post and cross sections had also been impacted, causing denting. The surveyor highlighted that both the security cabin and metal posts were in a poor pre-existing condition, showing signs of previous impacts.

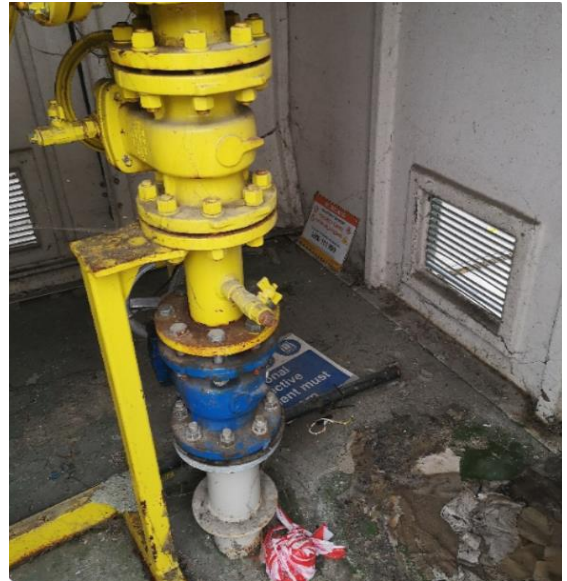
At the point of our instruction repairs had not yet been completed, immediately we arranged for one of our Surveyors to attend site. The inspection confirmed that the housing unit had been damaged across three sides. The impact caused the fibre glass to become split and cracked, resulting in the unit moving from its base. The Surveyor also noted damage to the gas pipes inside, including the gas regulator unit, which also required repairing. Due to the damages our Surveyor confirmed the entire unit would require replacing.

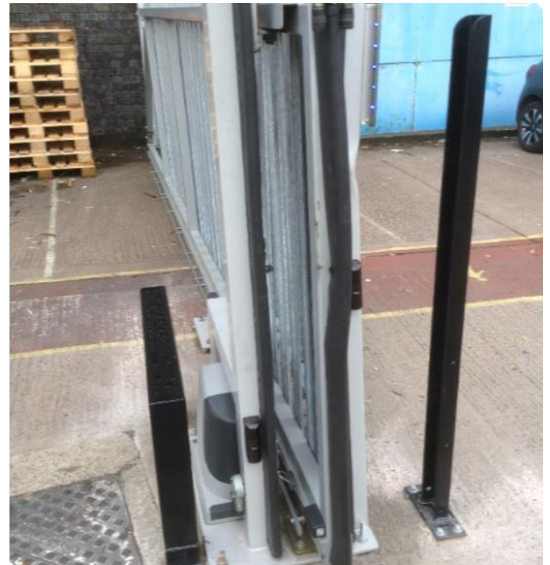
At the point of our instruction repairs had not yet been completed, immediately we arranged for one of the Surveyors to attend site. The inspection confirmed that damages had occurred to the steel gate, which had become buckled and distorted. Additional damage had also occurred to the gate post, which had become dislodged. The Surveyor was able to confirm that the electrical components had not been affected by the impact and that the operator unit was still functional.

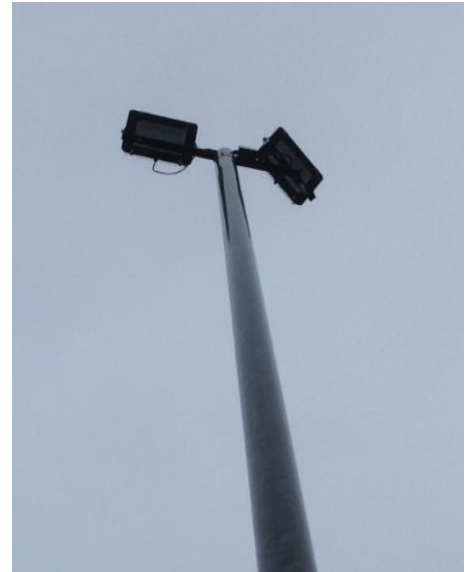
The Surveyor noted that the replacement lamp post had been installed with a new double floodlight and with new concrete foundations around the base for stability.

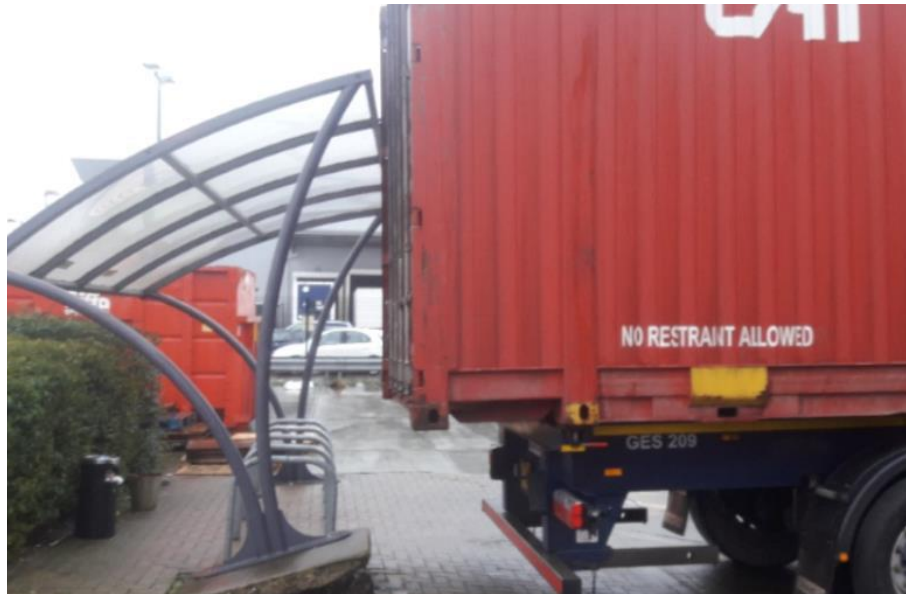
It was reported that the Policyholder vehicle reversed into the smoking shelter whilst delivering to the site.

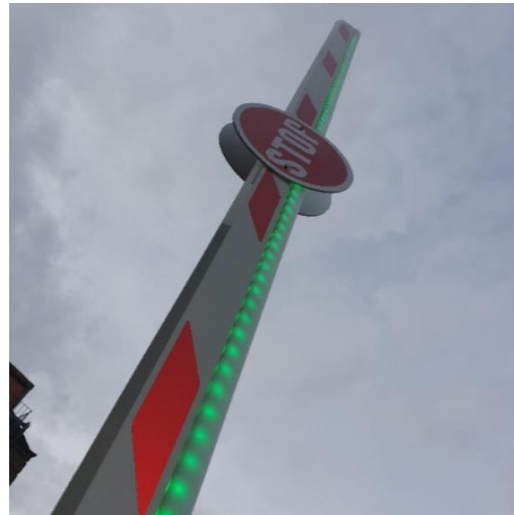
At the point of our instruction repairs had already been completed and we instructed one of our Surveyors to attend. From the images provided the Surveyor noted that the boom arm, which had already been installed, was a different design to the one in place at the time of the incident. The arm now had LED lighting to the underside, which appeared to be an upgrade. In addition, the signage had been replaced.

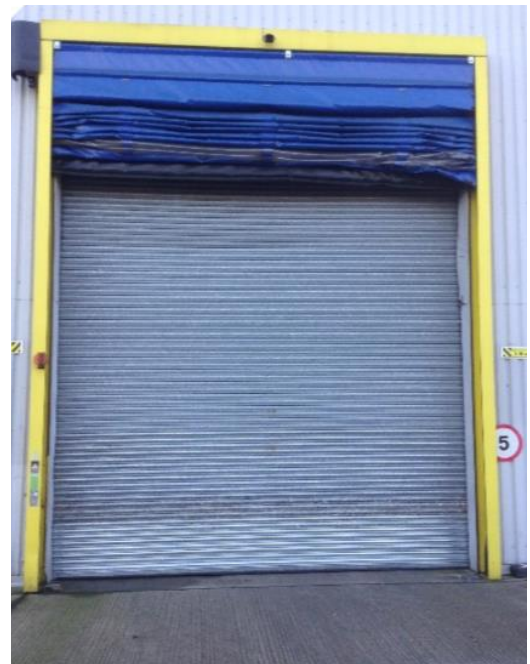
The Surveyor confirmed the doors would require replacing, however he also noted the general condition of the doors, as they showed signs of wear and tear associated with age.
