Property Damage Claims

Case Profiles- Cost Reduction and Early Reporting Benefits

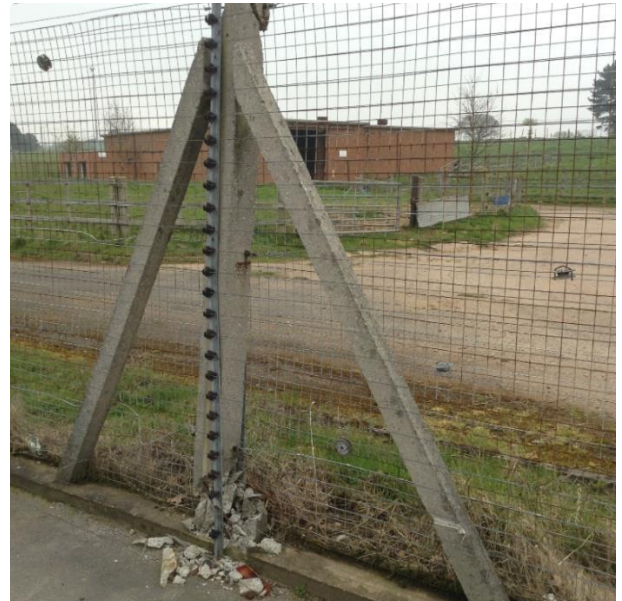
It was reported that the Policyholder vehicle collided with the electric fence and post.

Upon inspection the surveyor identified that the impact had resulted in the post being split and damaged, including breaking the joint at the base. The electric fence which surrounded the perimeter had also been damaged and required re-tensioning.

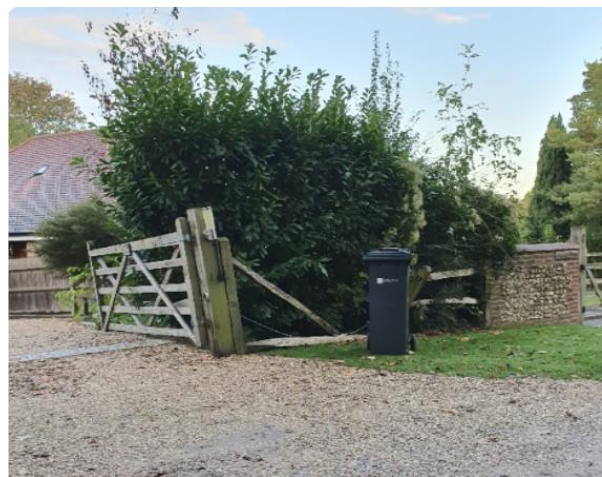
It was reported that the Policyholder vehicle collided with the gate and fence whilst reversing, causing subsequent damages.

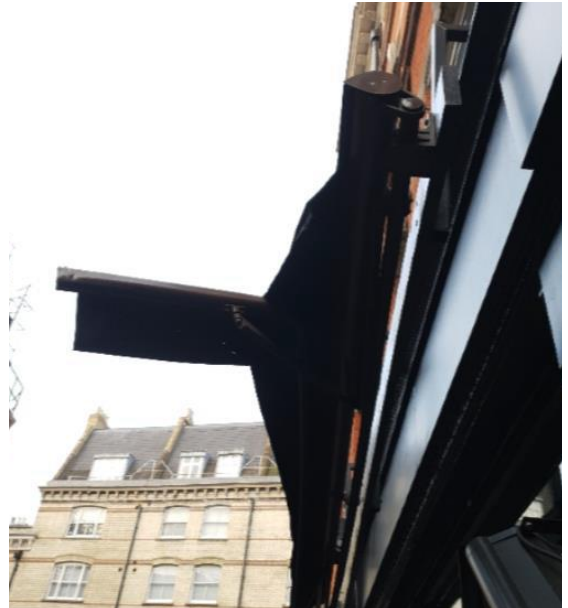
It was reported that the Policyholder vehicle collided with the front canopy of the third party's property causing subsequent damages.

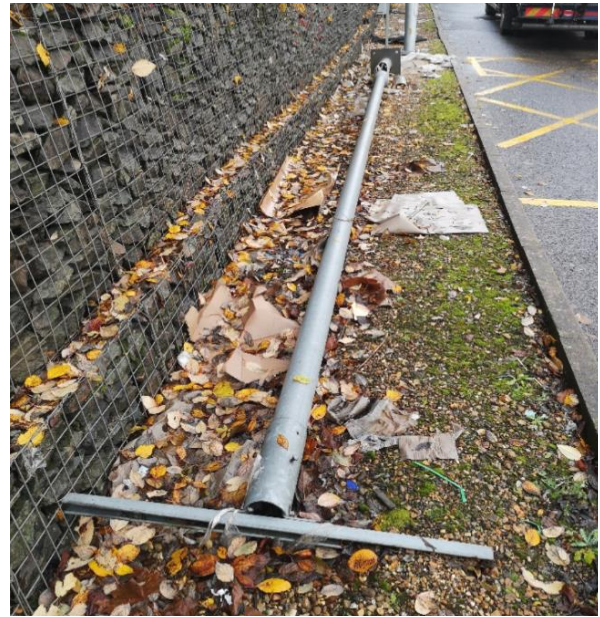
It was reported that the Policyholder vehicle reversed into a lighting column, knocking it over and smashing the floodlights.

The inspection confirmed that the column was 6m in height, with two main floodlights on a twin bracket arm, plus one smaller light halfway up the column. The Surveyor noted that whilst the column and floodlights would require removal and replacement, the twin bracket arm could be re used.

The third party confirmed they were happy for our contractor to complete the works, resulting in a saving of £2,834.25 / 49%.

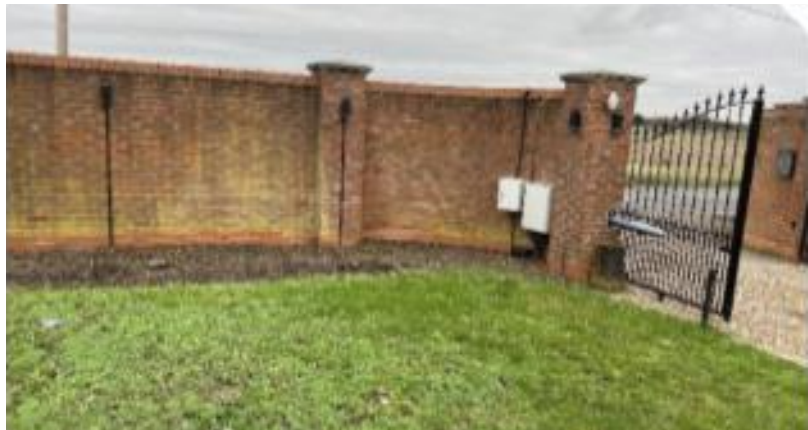
It was reported that the Policyholder vehicle reversed into the wall whilst manoeuvring into the site.

At the point of our instruction repairs had not yet been completed, immediately we arranged for one of our Surveyors to attend site. The inspection confirmed that the impact had resulted in damages to the right-hand side of the curved brick wall, with cracking evident on the radius of the curve. The third party advised that he would struggle to obtain a brick match to the existing wall and wanted any works to match exactly. In total the Surveyor observed 2 areas of vertical cracking caused by the incident, however he confirmed that repairs would be possible through cutting out the cracked bricks and replacing.

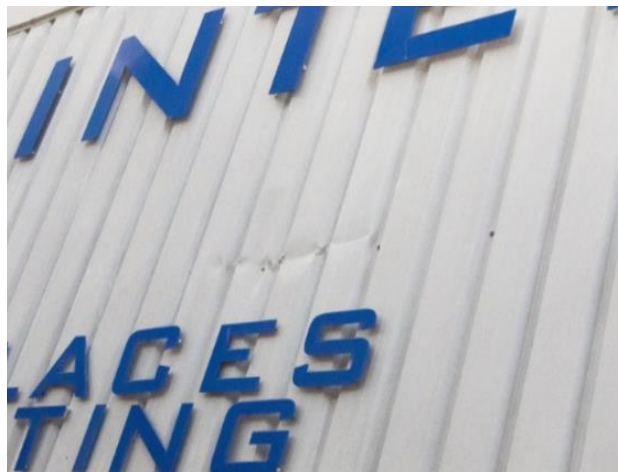
It was reported that the Policyholder vehicle collided with the side of the third party's property, causing subsequent damages to the cladding.

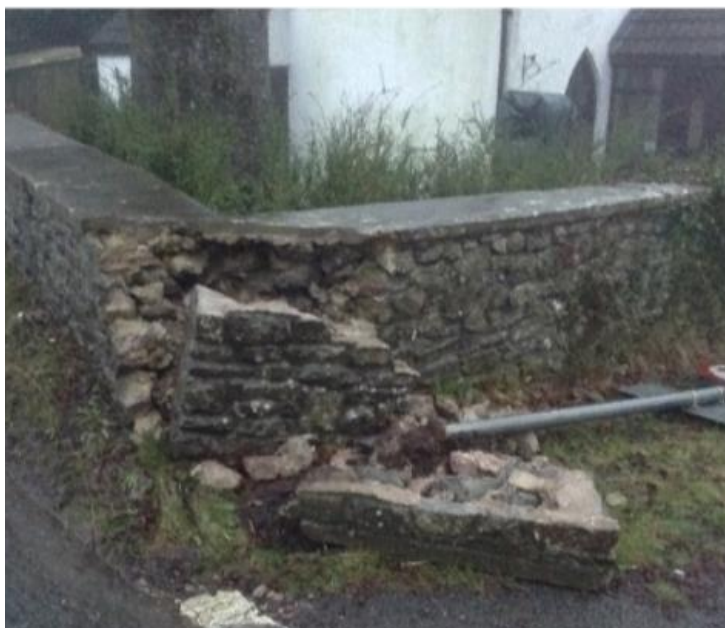
It was reported that the Policyholder vehicle collided with the corner of the wall.

The inspection confirmed damages had been caused to a section of the wall, which had partially collapsed, with further damage evident to the large concrete wall coping, which had cracked and dislodged as a result of the impact.
